April 21, 2021

Subject: **Arborist Report**
Diablo Water District, Oakley CA

WMB Architects is working with the Diablo Water District (DWD) on the proposed expansion of their maintenance facility, in Oakley CA. The City of Oakley requires an **Arborist Report** be prepared as part of the project submittals. HortScience | Bartlett Consulting (Divisions of the F.A. Bartlett Tree Expert Co.) was asked to prepare an **Arborist Report** for the project. This letter responds to that request.

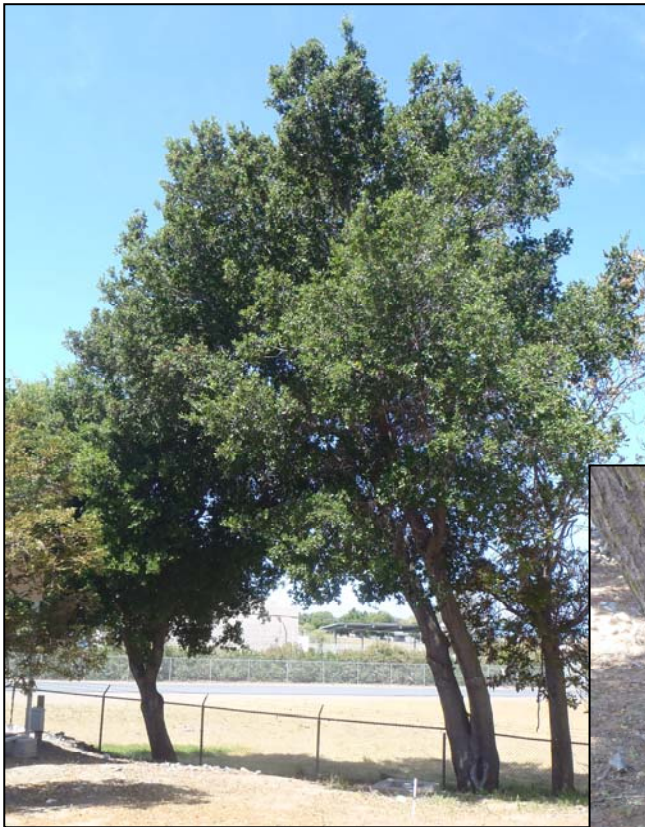
- Trees #351 and 352 were coast live oaks (*Quercus agrifolia*) growing along the fence line between the empty lot and the existing DWD treatment facility. Both trees were semi-mature, with #351 measuring 19" in trunk diameter and #352 measuring 21" and 20" (it had two stems). Coast live oak #351 was in good condition and #352 was in fair, primarily as a result of the trunk having grown around the fence (Photo1, following page).

Photo 1 (L): Looking northwest at coast live oaks #351 (L), 352 (center) and tree of heaven #353 (R), with the undeveloped lot in the background. Coast live oaks were in good and fair condition, respectively. Most of the trees of heaven were in poor condition and the species is invasive.

Impacts from the proposed changes were estimated for each tree. Based on my assessment of the plans, Coast live oaks #351 and 352 can be preserved, with ~10' clearance between the trees and the adjacent infiltration basin. Both of the coast live oaks qualified as *Heritage* trees. Table 2 provides the recommended action for each tree. Preservation of trees is predicated on all contractors following the **Tree Preservation Guidelines** provided on the following page.

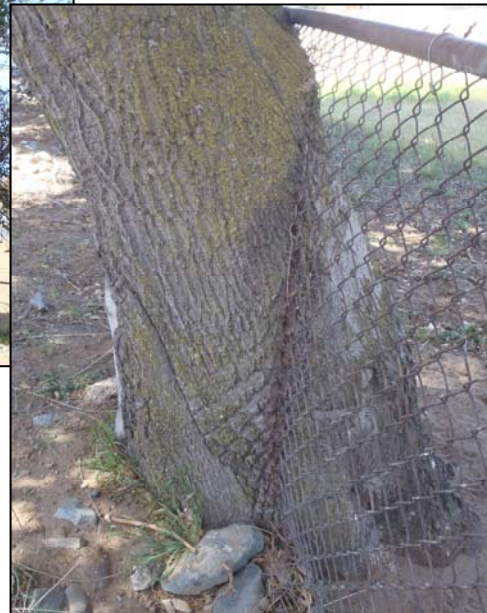
Inset (below): Shows the fence embedded in the trunk of coast live oak #352, the primary reason for its fair condition.

2. Plan to either leave the portion of the fence that is embedded in the trunk of tree #352 in place by cutting it just outside the trunk.
3. A **Tree Protection Zone** shall be established around each tree to be preserved. No trenching, excavation, construction or storage of materials shall occur within that zone. No underground services including utilities, sub-drains, water or sewer shall be placed in the **Tree Protection Zone**. Spoil from trench, footing, utility or other excavation shall not be placed within the **Tree Protection Zone**, either temporarily or permanently. The **Tree Protection Zone** for trees #351 and 352 shall be defined at 10' NW (at the limit of the infiltration basin) and at the dripline in all other directions.
